STUDIES FOR THE CONSERVATION OF THE MONUMENTAL SCULPTURES IN TERRACOTA FROM THE MONASTERY OF ALCOBAÇA (PORTUGAL): PROJECT TACELO

João Coroado*; Ricardo Triães*; Cecília Gil**; Eduardo Ferraz*; Fernando Rocha***

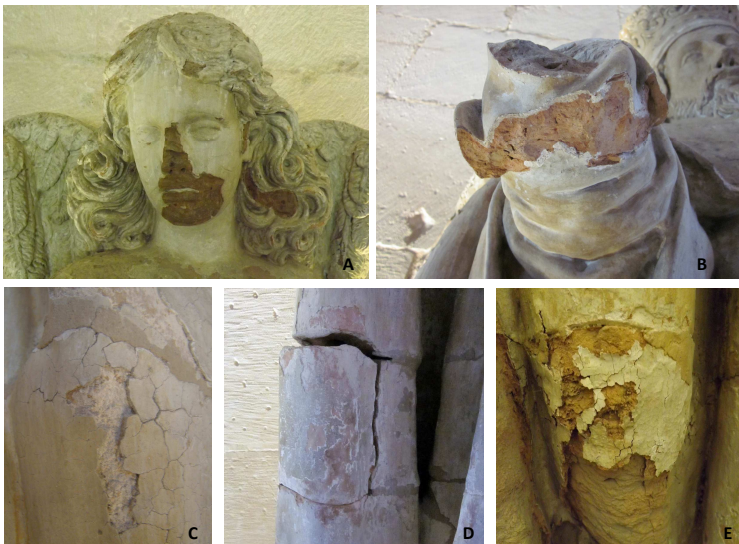
The most relevant problems arising from the materials alteration and alterability, and concerning the terracotta under layer, are the evident loss of significant parts of the sculptures, the loss of terracotta through flaking and low cohesion on the surfaces and the existence of cracks and fractures due to the material nature or fabrication processes (Fig. 5). These problems are mainly consequences of human actions (either during dismantling and assembling the sculptures, through vandalism or even as a result of the lack of conservative actions), of water absorption by capillarity and of the exposure to extreme environmental conditions.

Other relevant aspect identified in these sculptures is related with the lack of adhesion between layers, resulting from the materials' differences in behavior and the alterations they suffered. The original polychrome layer is covered with a white layer, already very altered too.

Fig. 5 – A) Loss of material by dustiness; B) Loss of a hand; C) Craquelures; D) Fractures; E) Flaking

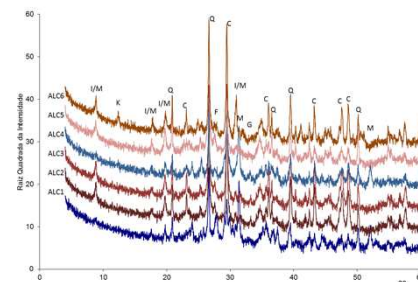
The samples mineralogy is very similar and fundamental constituted by quartz (SiO₂) and calcite (CaCO₃), which represent the phases that occur with more intensity, except for ALC 1 and ALC 4, where gehlenite occur (Ca₂Al₂SiO₇), and illite/muscovite is practically untraceable. Gehlenite results from the thermal transformation between calcite and aluminosilicates when the firing temperature is at least over 850°C. As secondary phases phyllosilicates as muscovite (KAl₃(Si₃O₁₀(OH,F)₂) were observed, as well as goethite (α-FeO(OH)) and potassium feldspar(KAlSi₃O₈). In sample ALC 6 the presence of kaolinite was observed (Al₂Si₂O₅(OH)₄) (Fig. 6).

Fig. 6 – Diffractograms of the samples collected from the Monastery's storage. Q-Quartz; I/M-Illite/muscovite; K-Kaolinite; C-Calcite; M-Melilite(gehlenite); G-goethite.
